Nitrotec[®]

The Alternative to Cr Plating

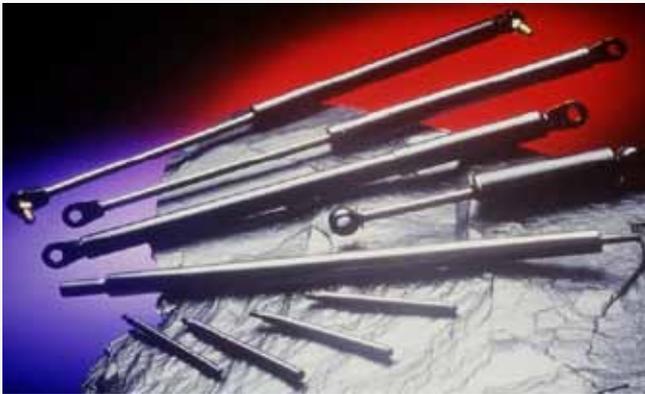
PISTON RODS

Material: 0.1-0.4% Low Carbon Steel

A traditional technique for the manufacture of Gas Piston Rods is to machine the Rod from hard chrome plated low or medium carbon steel bar. Nitrotec® processing is capable of producing all of the design requirements for the application:

The Nitrotec 'S' surface treatment provides a minimum of 25 µm compound layer with a surface finish of 0.15 µm maximum, which is competitive with chrome plating.

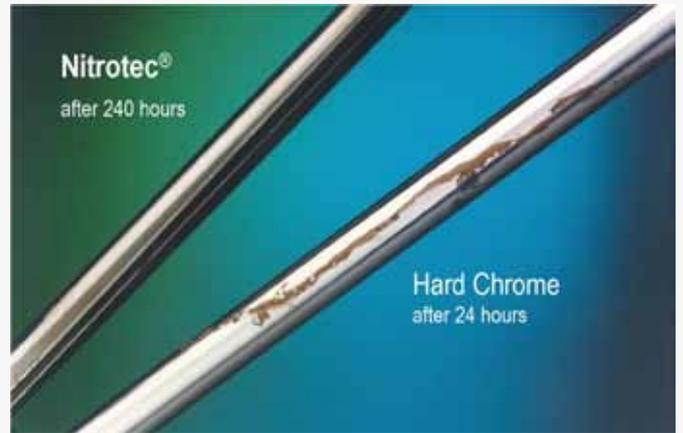
Material:- Typically 0.15-0.4% carbon steels.

Nitrotec 'S' is a treatment followed by a mechanical polish to regain the surface finish followed by a post oxidising treatment. This polished finish produces an improvement in both frictional characteristics and corrosion resistance. This is demonstrated by the 2 struts shown after neutral salt spray test where 15 microns of hard chrome plating lasted 24 hours yet the Nitrotec 'S' strut exhibited no corrosion after 240 hours neutral salt spray test.

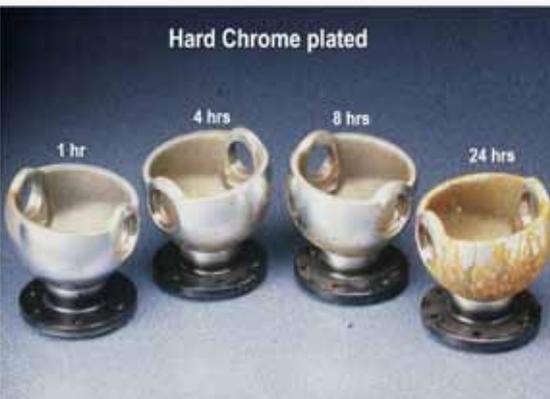
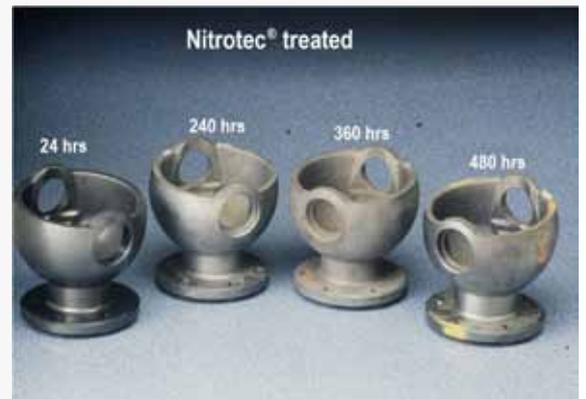
SWIVEL HUB

Material:- 0.32-0.40% carbon steel, 1.3-1.7% manganese steel (forged), hardened and tempered to 201-255 Hb.

Many service complaints were being received about oil leaks around the seal which wiped over the bowl. The leaks were caused by the corrosion of the chrome plating, which was lifting up in flakes and cutting into the seal. The result being that the oil leak from the bowl depleting the oil reservoir inside the hub. One engi-

neering solution experimented with was to fit the unit with a leather gaiter, packed with grease. Unfortunately, corrosion occurred again giving rise to quality issues. A Nitrotec® treatment on the component with the correct surface finish produced greatly improved corrosion resistance, with an added bonus of improving fatigue strength to uplift available axle load.
